MYGEC, Bodrum, 23 – 24 September 2019

# Learning from Observations of Geotechnical Performance in Earthquakes

**George Gazetas**

**National Technical University of Athens, Greece**

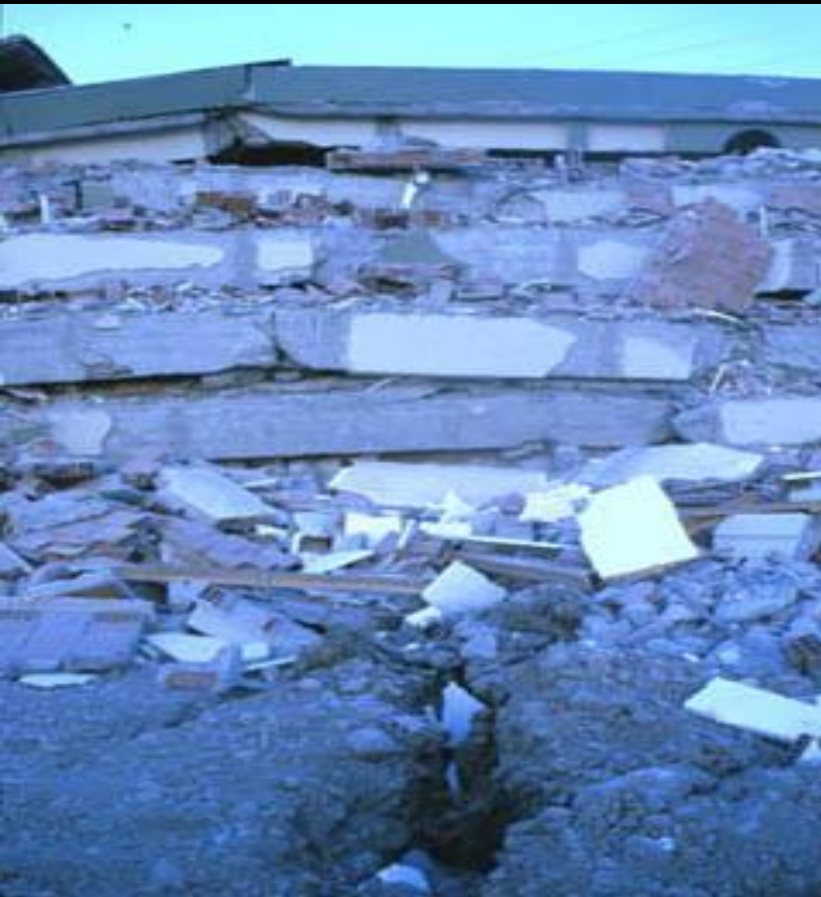
# Kocaeli, Turkey, 1999

**5 – storey building  
collapse**

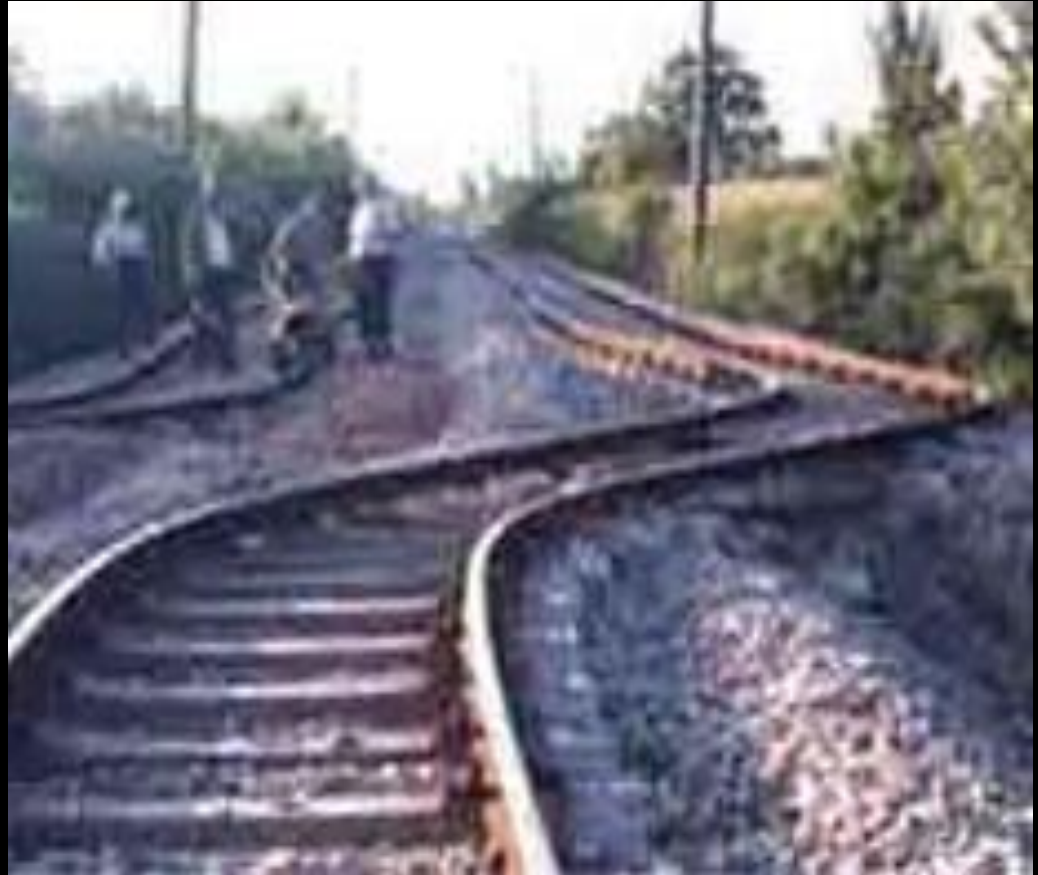
**Deflection (offset) of rail**

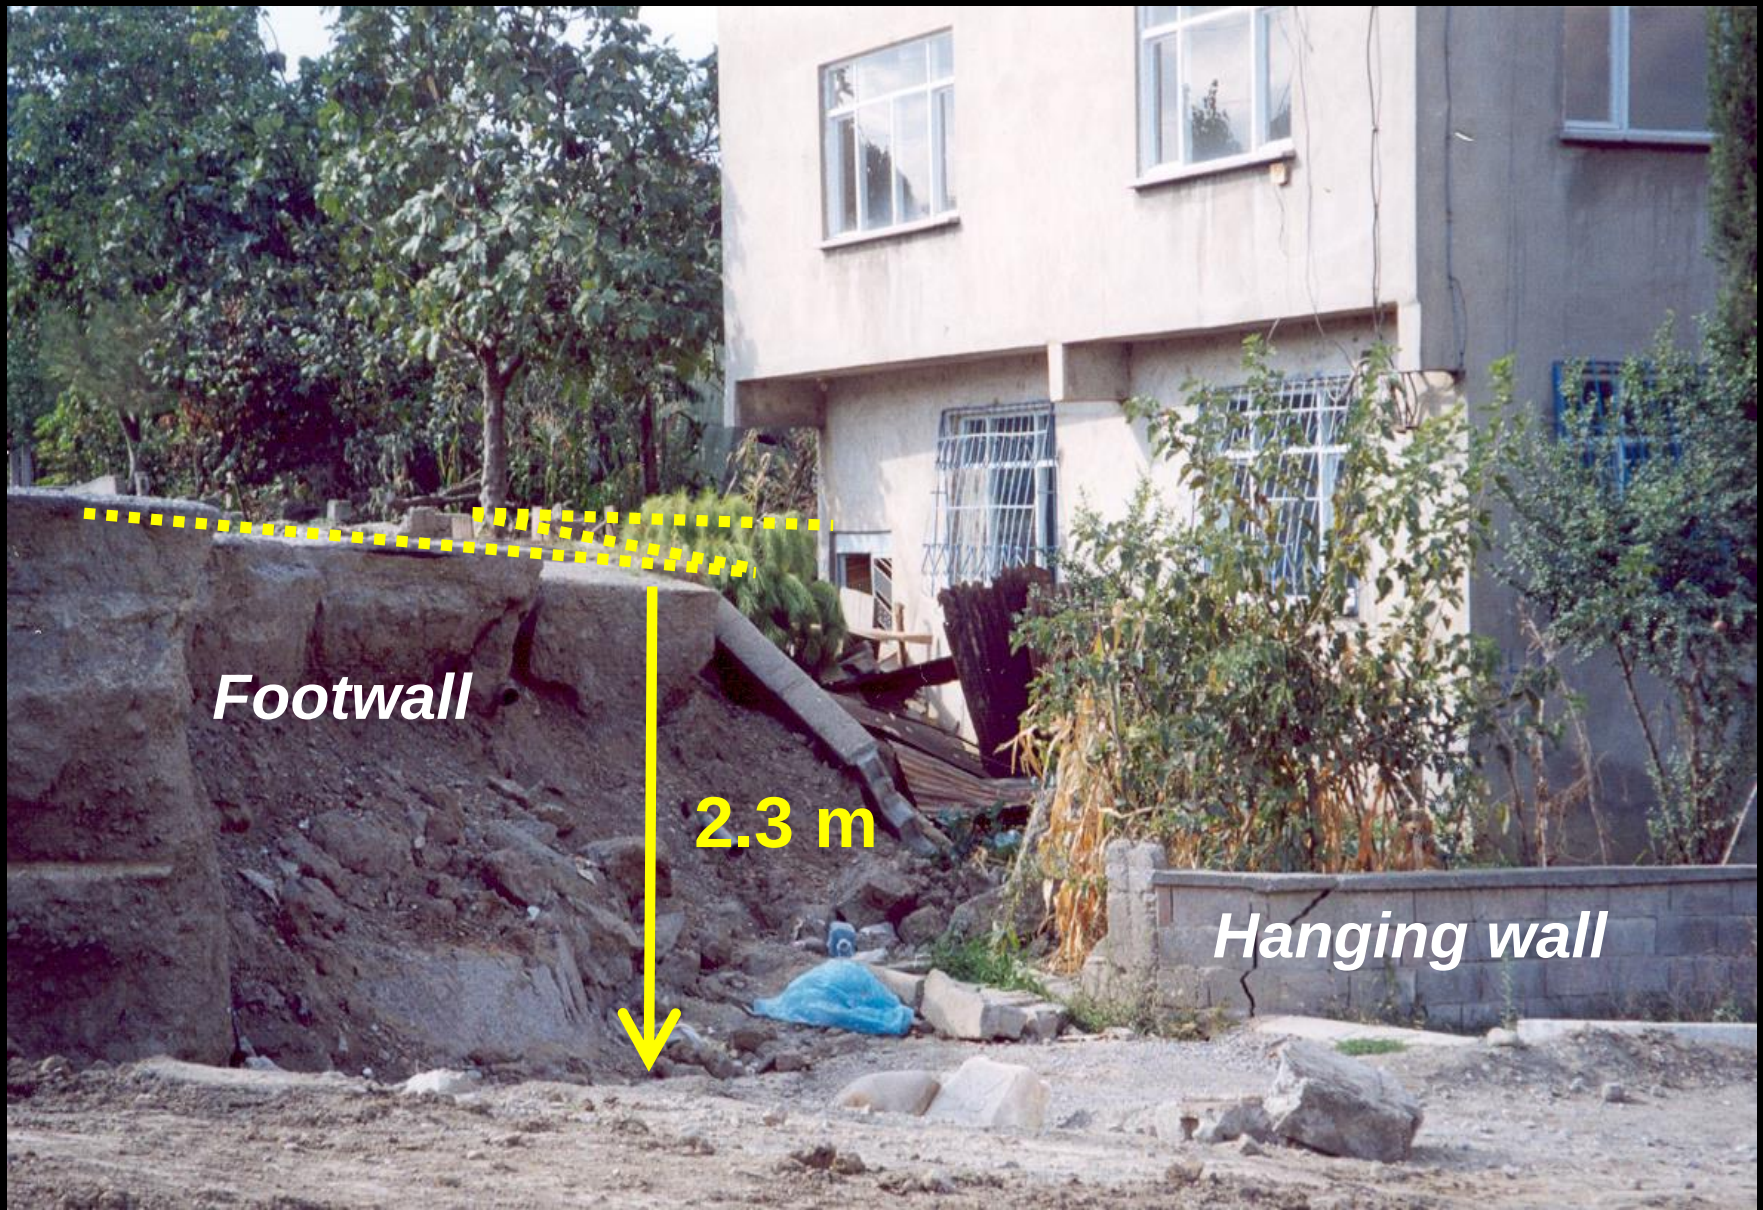
## ***5-storey Building 1 : NO Damage***

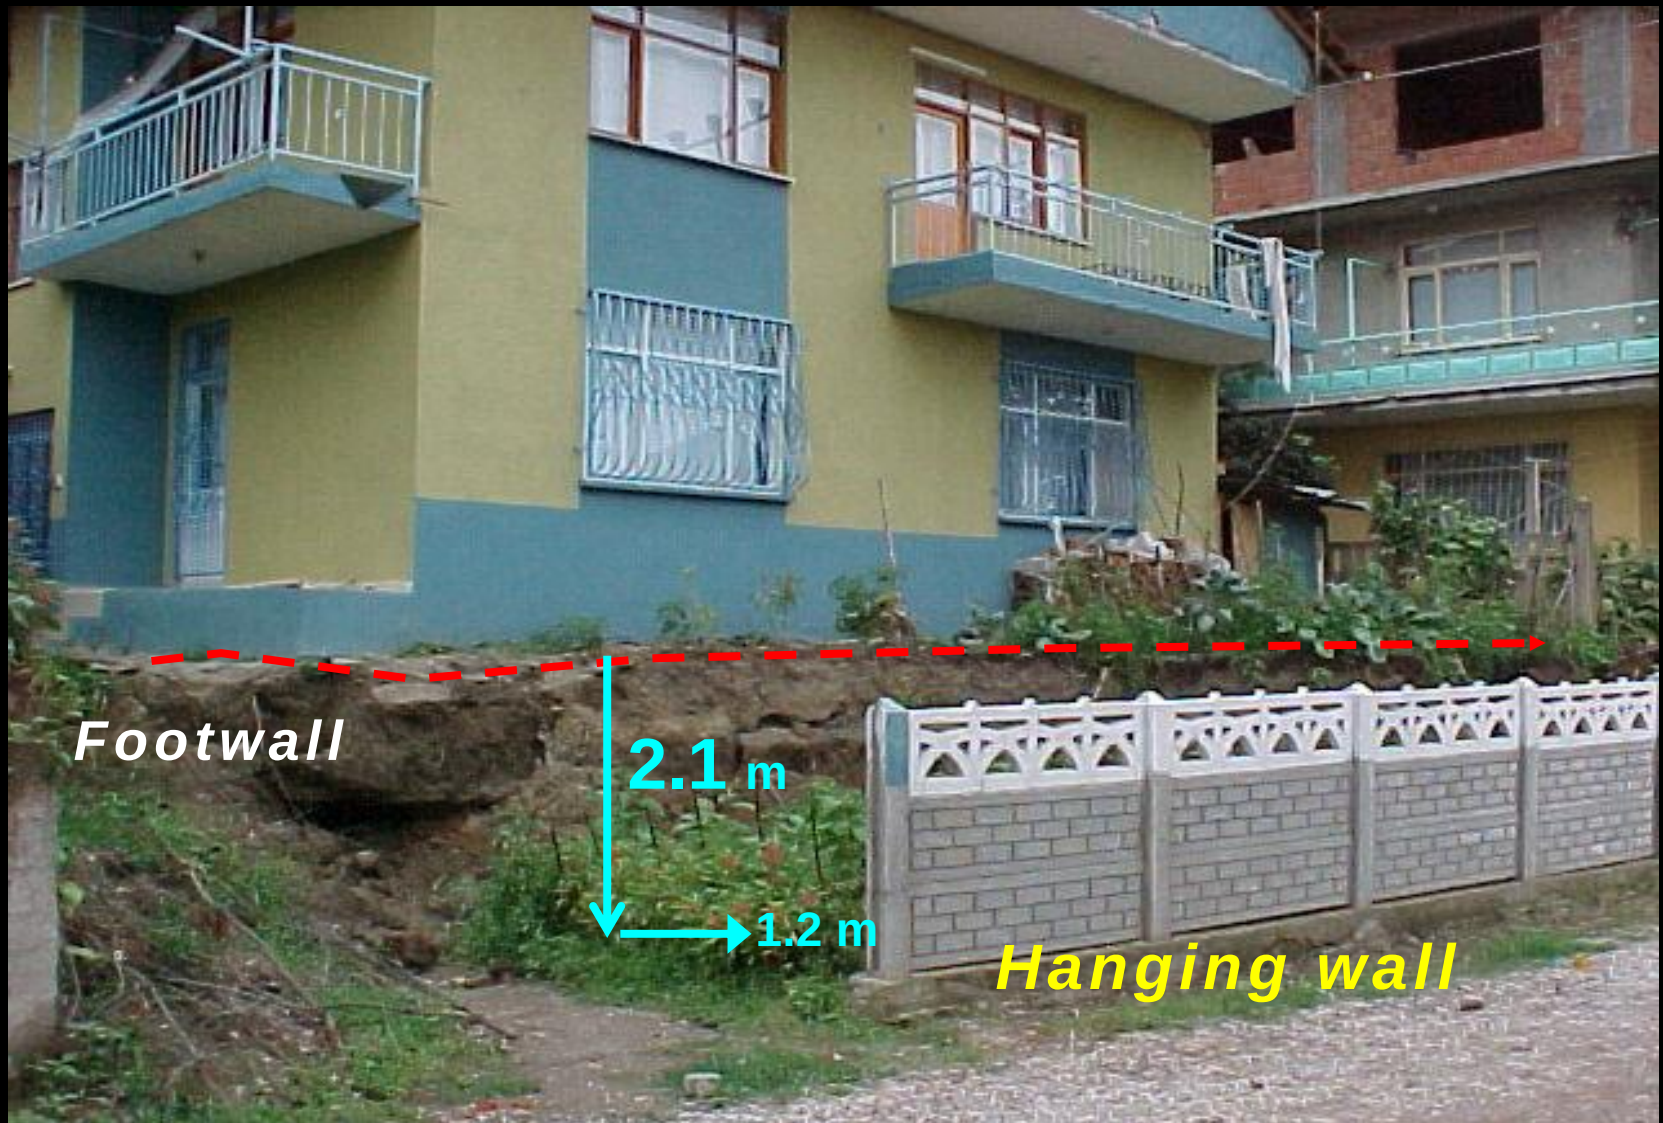
## **2.5 storey Building 2 : NO Damage**

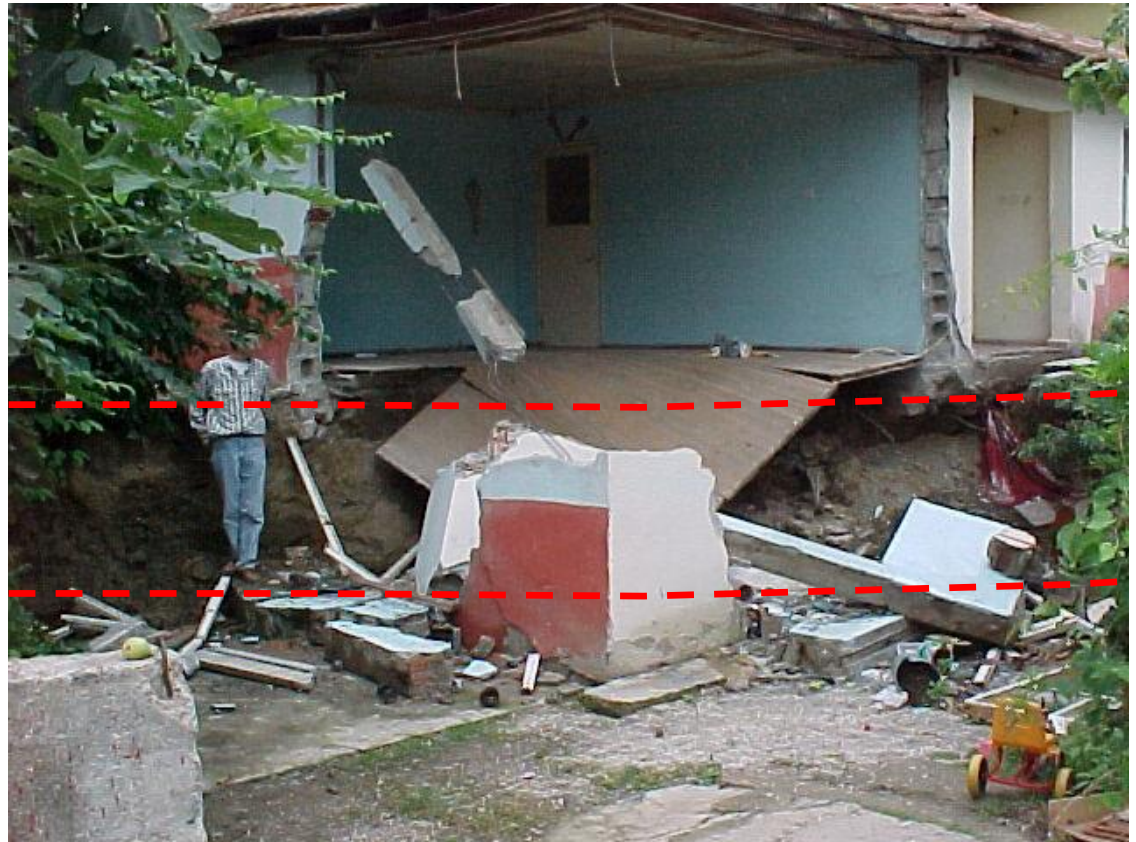
## 1-floor building: **Partial Destruction**

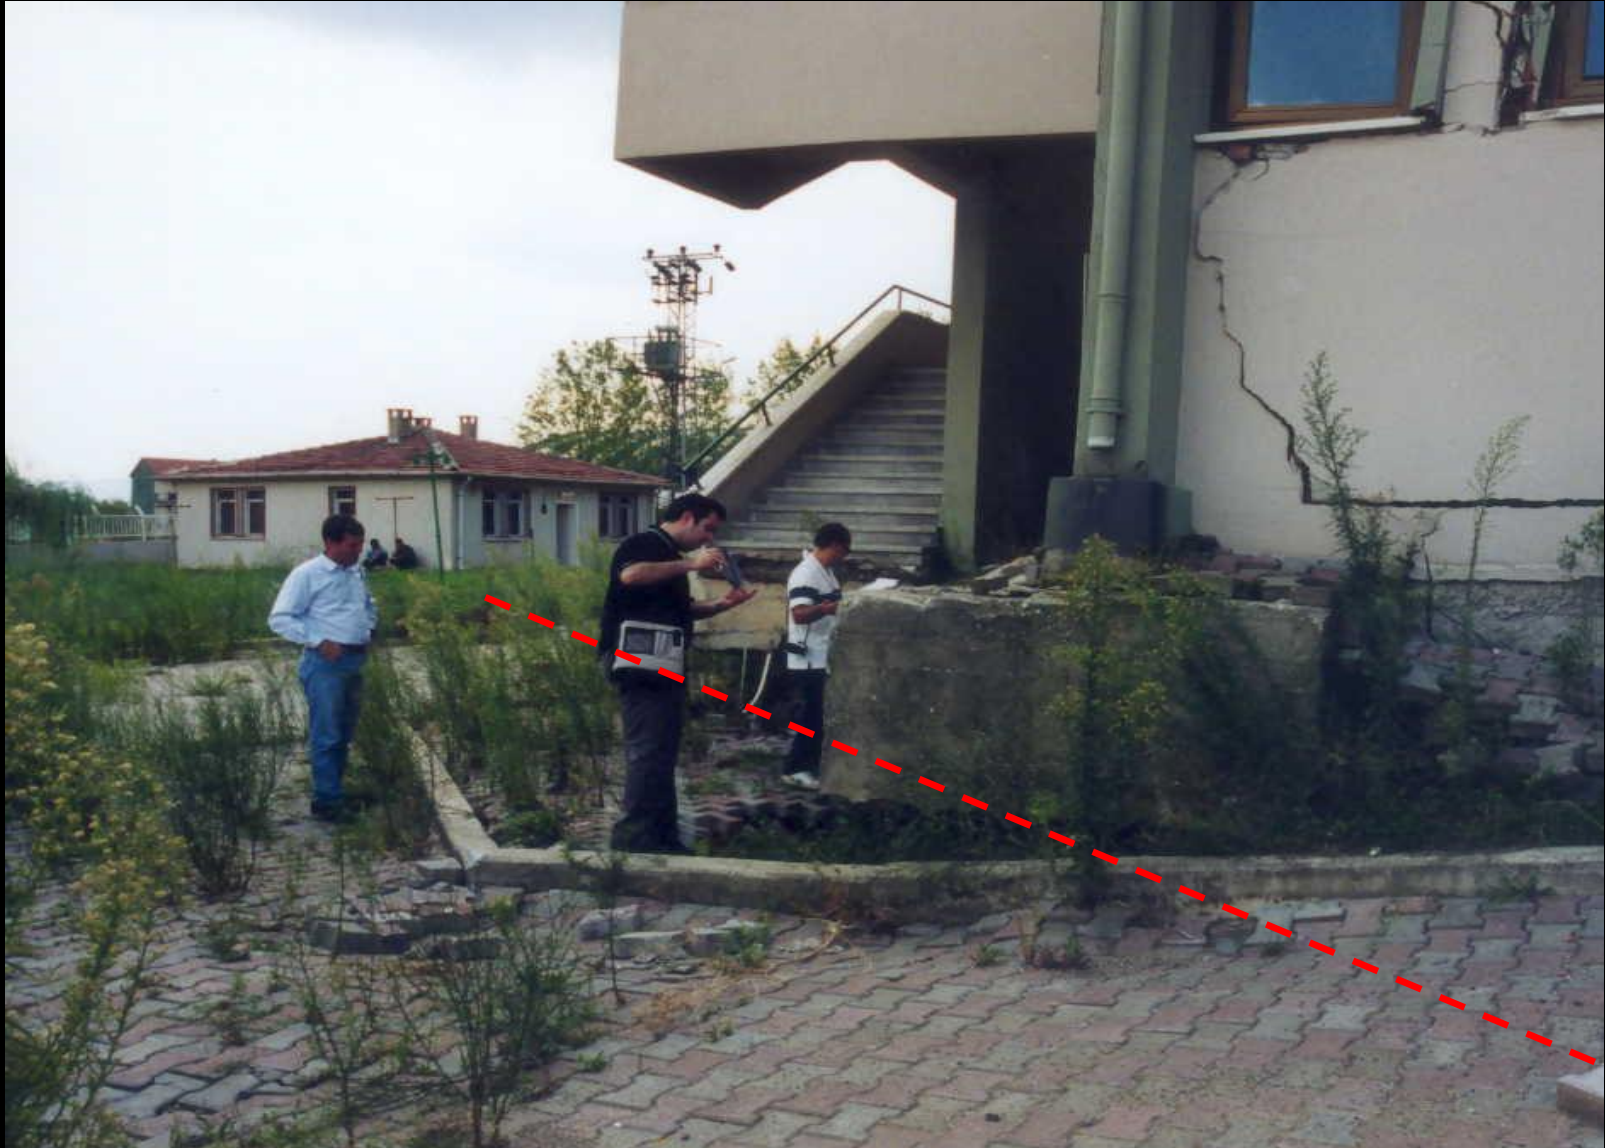
## ***STADIUM : DAMAGE***

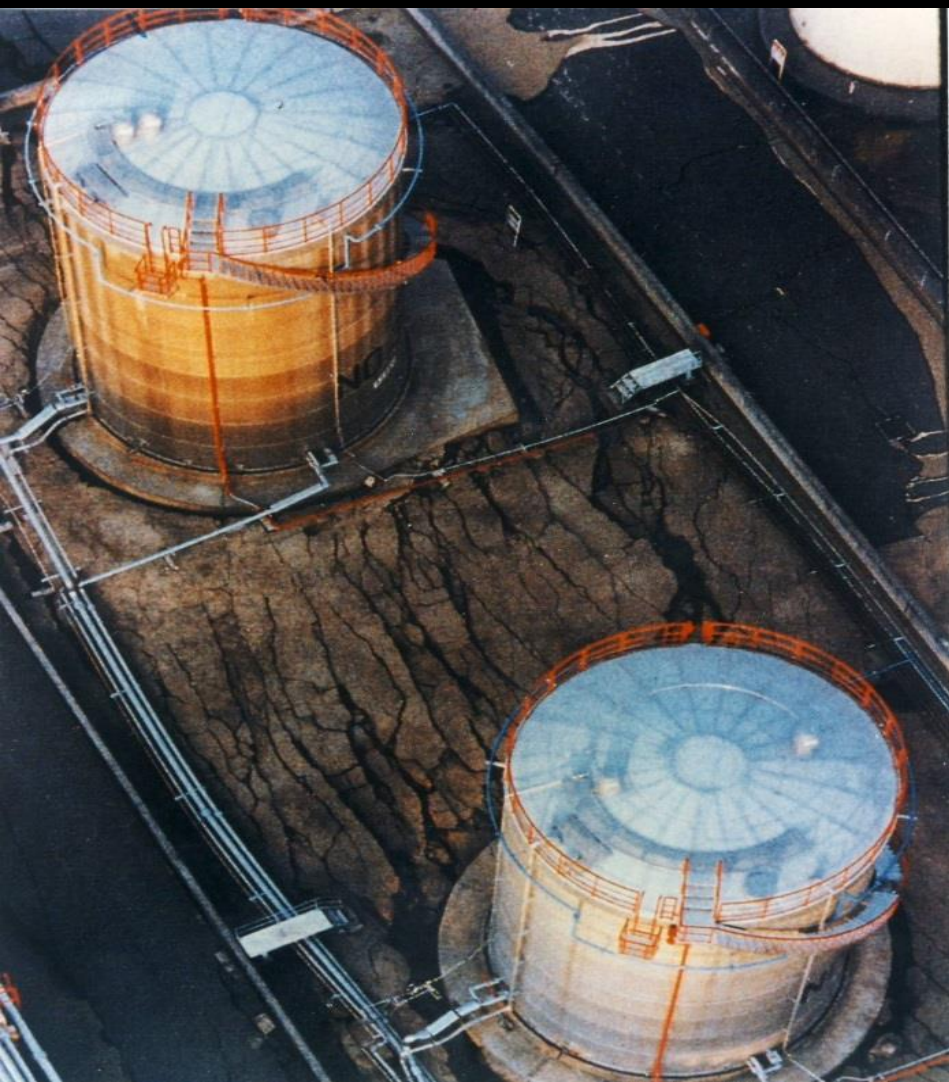
**PILE FAILURE**
